***Moddershall Valley Conservation Area Appraisal***  
**January 2016**

Stafford Borough Council

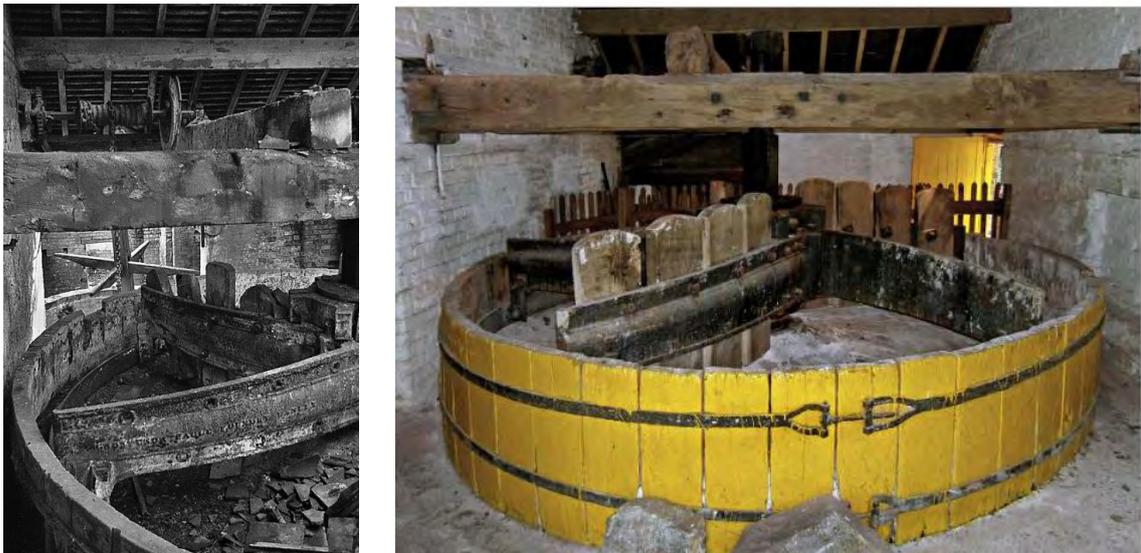
**Figure 6:** The grinding pan at Mosty Lea Mill, before and after restoration

- 8.5 **Grinding Pan:** The calcined bone or flint was taken into the pan room where it was spread out in a circular vessel or 'pan' and covered with water. The pan was typically about 12 ft (4m) in diameter with iron hooped timber sides of about 3 ft (1m) high. Later iron was used for the pan, once a method for removing iron particles from the product by magnetism was developed. The floor was of Flintshire or Yorkshire chert on a clay seal, and a vertical shaft driven from below drove arms or 'sweeps' to push chert runners around the pan to grind the product.

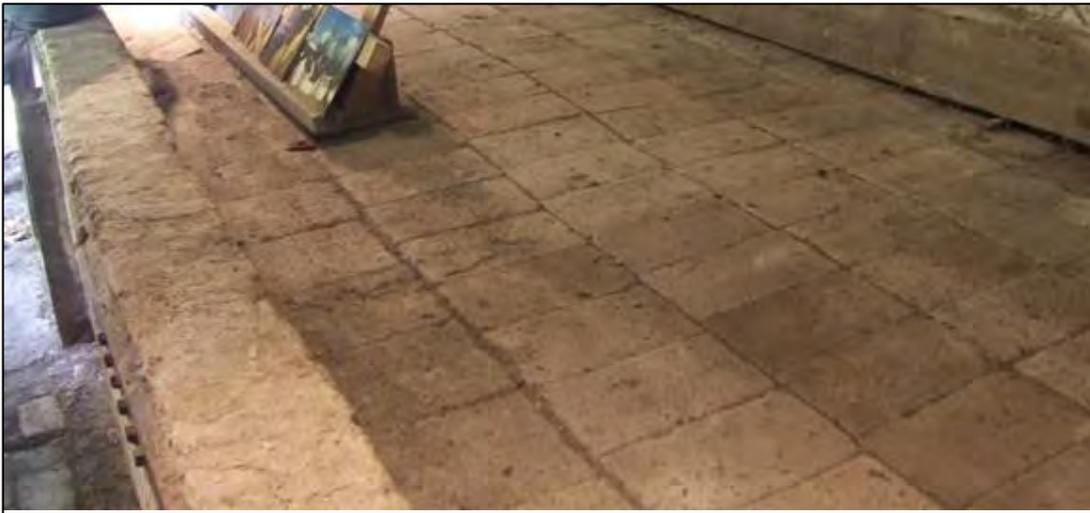
**Figure 7:** Drying bed at Mosty Lea Mill

- 8.8 **Drying Kiln:** Initially drying could take place outdoors in a pan by evaporation alone. But this wasn't suitable for larger scale production. The drying kiln had a brick pavement surrounded by low sided walls, with flues underneath running from a coal fire to a chimney stack. Dried blocks of about a foot square were then transported to the Potteries.

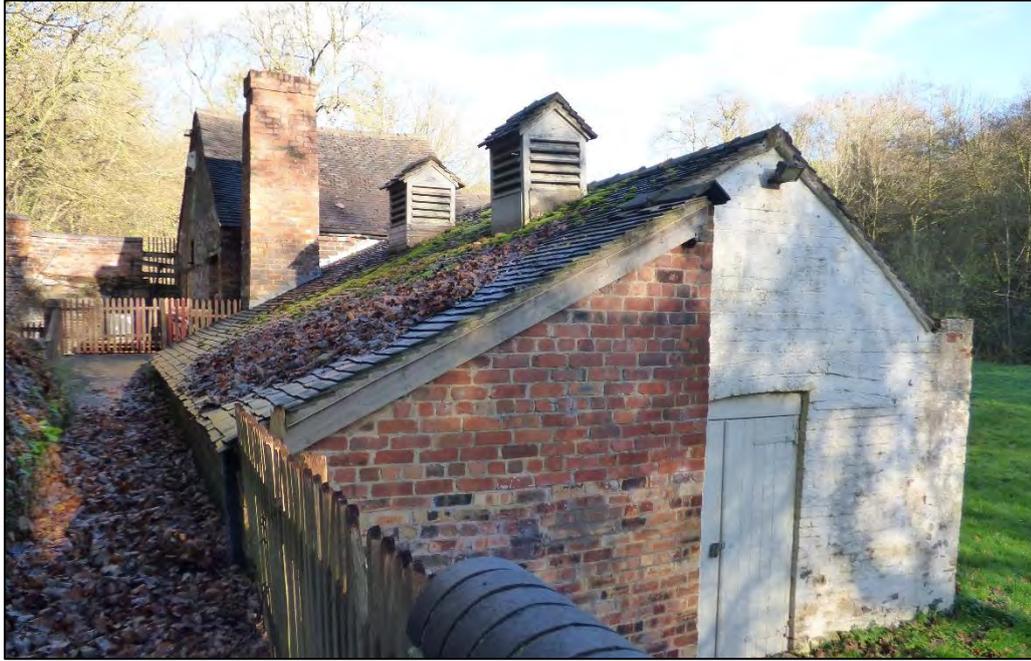
**Figure 8:** Roof top vents and chimney stack identify the drying kiln at Mosty Lea Mill

- 8.11 A cluster of small interconnected buildings identifies the mills as distinct from the dwellings or agricultural buildings within the area. Other key features are the water wheel, which would be sited unhoused adjacent to the mill, and where there were drying kilns, a tall industrial chimney stack and roof top vents to the drying shed. Wheels survive at Splashy Mill, Mosty Lea, Wetmore Mill, Ivy Mill, Hayes Mill and Coppice Mill, and stacks at Mosty Lea, Wetmore, Ivy Mill and Hayes Mill (albeit a mid-20<sup>th</sup> century rebuilt stack).

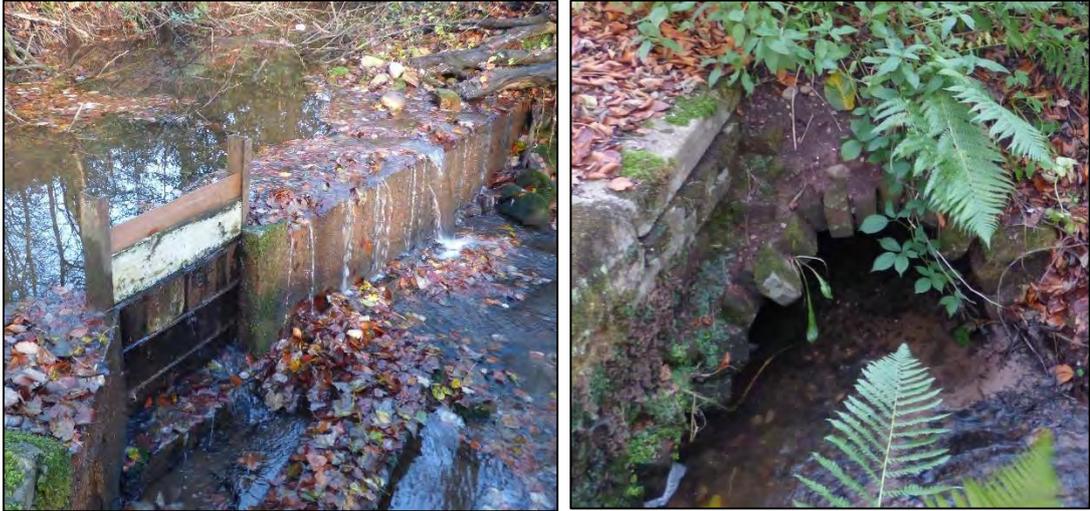
**Figures 11 & 12:** Sluice gate and weir between Wetmore and Mosty Lea Mills, and brick-lined culvert taking the stream under Mill Lane from Splashy Mill to the former Ochre Mill site

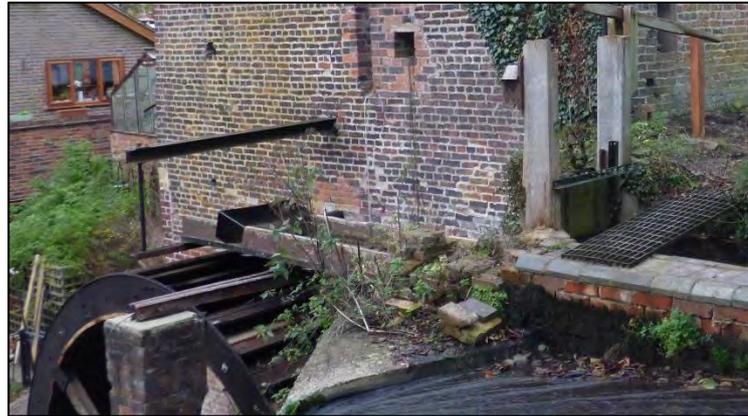
**Figure13:** Wooden laundry and sluice gate at the overshot wheel of Splashy Mill

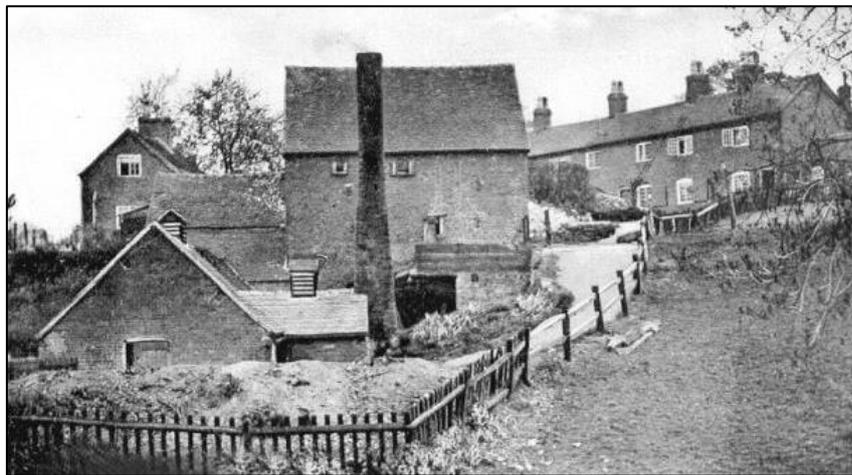
**Figure 14:** Exposed brick elevations at Hayes Mill, Hayes House, and Millbank Cottages, c.1900, now all painted or rendered.

- 10.1 Throughout the Mills Character Area, for domestic and agricultural buildings, as well as the mills, the building materials are of local bricks for walls with plain clay tiled roofs. Usually the bricks are dark orange, but at Splashy Mill, for example, over-fired bricks create a darker blue or brown appearance. Roofs are simple gable ended, but an appearance of complexity often results from the clusters of mill sheds and outbuildings. Only on the higher status Hayes House is a hipped and slated roof found.
- 10.2 Many of the historic buildings have been painted or rendered in white or cream, but this is rarely a historic finish. Most were of exposed brickwork until the late 19<sup>th</sup> or early-20<sup>th</sup> century. At Hayes House alone, the stuccoed finish is original to the building.

- 10.3 Bricks are commonly laid in a variety of bonds, most commonly 'Flemish bond', where headers and stretchers alternate in rows, or 'Flemish Stretcher bond', where three stretcher rows are divided by one of alternating headers and stretchers. At Splashy Mill, the dark bricks are laid in an English garden wall bond, where three rows of stretchers alternate with a single row of headers.

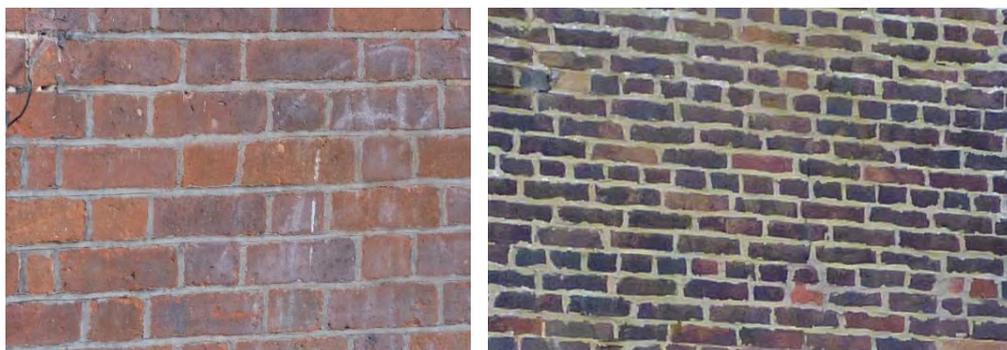
**Figures 15 & 16:** Typical orange bricks in a Flemish bond contrast with the dark bricks and English garden wall bond at Splashy Mill.

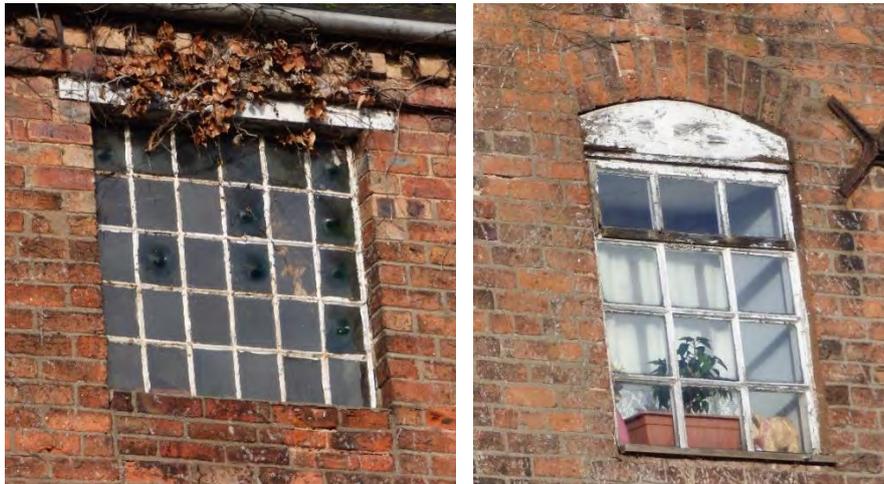
**Figures 17 & 18:** Multipane window at Stone Mill with dentillation to eaves above, and replacement window with simple segmental arched header.

- 10.4 The mills and farmsteads were strictly functional buildings, and architectural detail is sparse. Simple straight heads or segmental arches to window and door openings, and dentillation to the eaves are common. Roof verges are typically plain closed without corbelling or bargeboarding, although a single example of decorative bargeboarding is found at Grove House.
- 10.5 Original window or door joinery has often been lost to the mills, and a patchwork of replacements is typical. At Stone Mill some multipane iron windows can be seen to the upper storeys, but simple side opening timber casement windows were typical, divided into 3 or 6 panes. These have been reinstated at Mosty Lea Mill alongside plank and ledge doors or shutters.

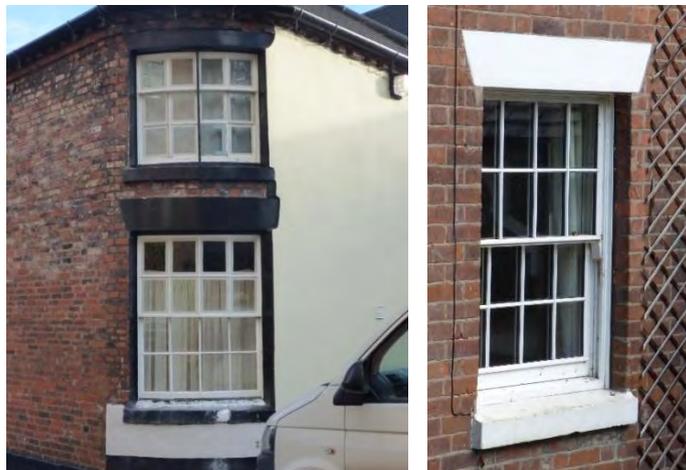
**Figures 19 & 20:** Sash windows at the mill houses of Stone Mill and Wetmore Mill

- 10.6 Survival of historic windows on the domestic buildings is better, including simple timber side opening casements to the cottages of Ivy Mill, sliding sash windows at Grove House, Hayes House and Wetmore Mill house. At the mill house at Stone Mill, curved sash windows negotiate a corner adding an interest to an otherwise routine dwelling.

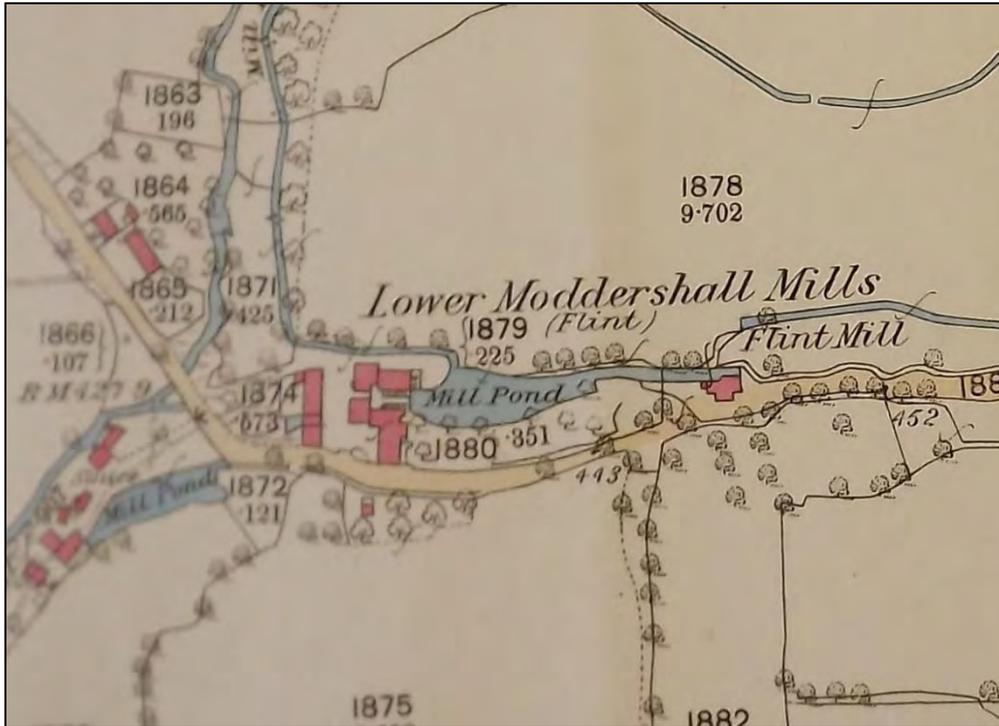
**Figure 26:** OS first edition map of 1879 showing former cluster of mill buildings, of which only the north mill and outbuilding now survive.

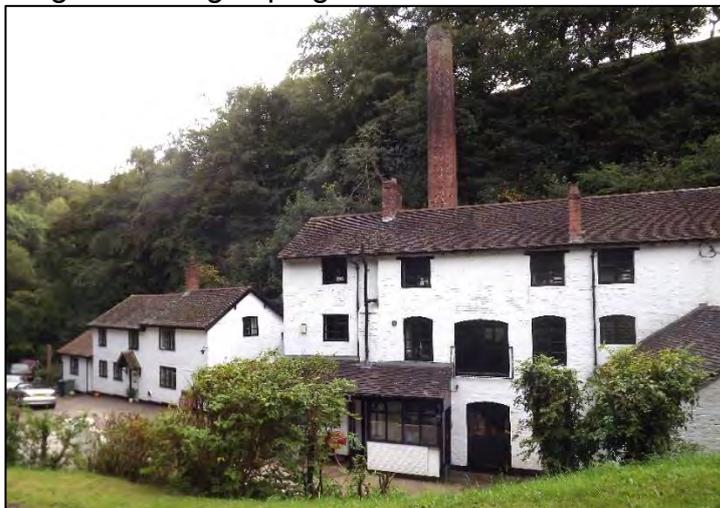
**Figure 32:** Ivy Mill, with cottages to the left and industrial mill to the right.

11.14 **Ivy Mill (grade II listed)** is thought to have been built about 1740 for linseed oil production. Originally known as 'Oulton Mill', it continued in use as an oil mill, but was also grinding flint by 1782 and later grinding bone. It ceased grinding in 1966 and closed in 1977. Its high breast water wheel, calcining kiln, octagonal chimney stack, mill pool and associated buildings and mill cottages survive in situ. Internally two grinding pans remain in situ.

11.15 Ivy Mill is one of the few buildings within the Conservation Area to betray the historic industrial nature of the Moddershall Valley in views along the main A520 Longton Road. The 60 foot chimney stack draws attention to the cluster of buildings, confined by the gorge of the valley at this point into a linear string of buildings up against a dramatic cliff face backdrop.

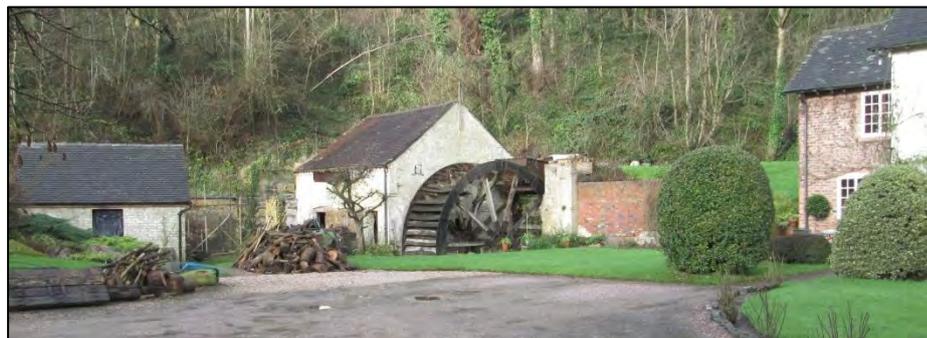
**Figure 39:** Collection of buildings at Coppice Mill

11.20 **Coppice Mill (grade II listed)** originated pre-1720 as a paper mill, and was later owned by Henry Fourdrinier, famous for perfecting a machine for producing continuous paper in 1807. By 1851 the mill had turned to flint grinding. In 1953 the mill closed. Currently it is in a largely derelict condition, but being slowly restored. Waterwheel, flint kiln (separately listed), crushing pans, wash tub and gearing survive and the process is readily legible in the buildings. The millers’ house is in domestic use. The 600 yard leat running from the Nicholls Lane junction by Hayes Mill is also in the process of restoration, and the brick and stone weir to the former Stone Mill millpond survives in the private garden.

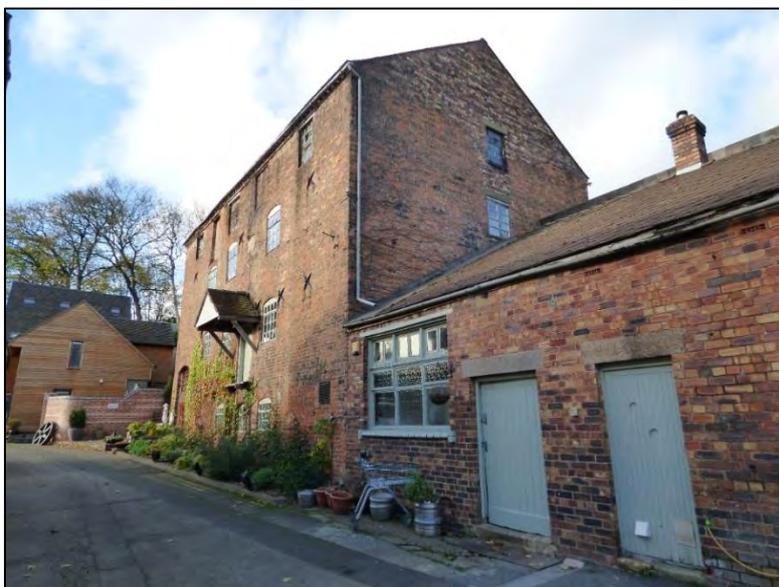
**Figure 40:** Stone Mill, now in use as a restaurant

11.21 **Stone Mill (grade II listed)** is a former corn mill, dating from 1795, and was the birthplace of “Stoney Richard Smith”, originator of Hovis bread. It is a more substantial four-storey five bay building than the typical flint mills, but it is a smaller building to its west that is now recognised as a former flint mill. During recent conversion to a dwelling, the former wheelhouse and evidence of the leat and power systems have been uncovered.

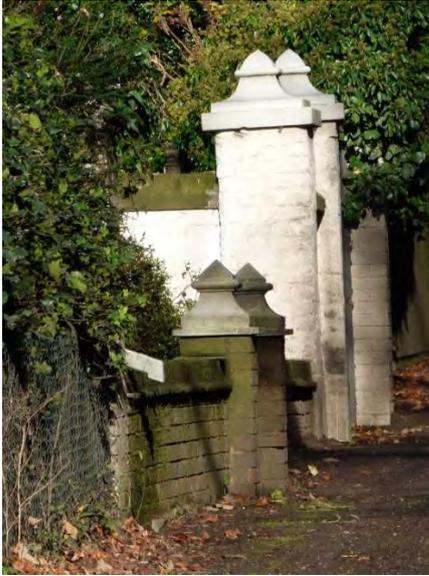
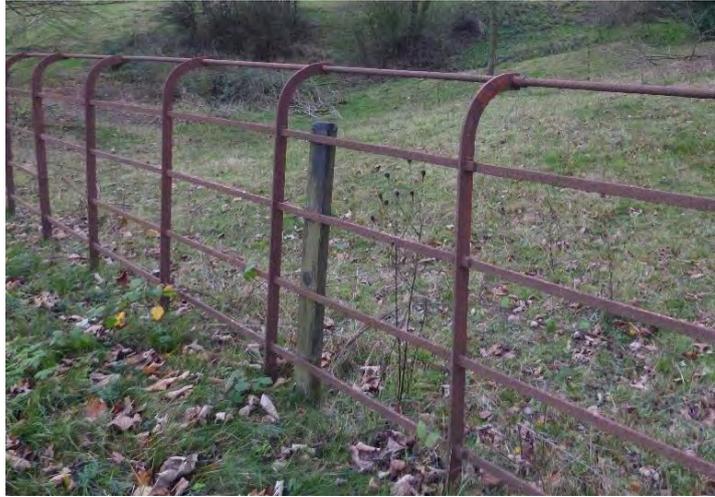
**Figures 43 & 44:** Gate piers at Grove House and iron 'estate' railings at the corner of Vanity Lane

12.3 Due to the topography, natural banks or the steep cliff faces of the valley often serve to create natural boundaries adjacent to the road. Occasional lengths of estate style, or simple vertical iron railings survive in some areas, usually in a poor state of repair, and fields are often bounded by timber post and rail fences.

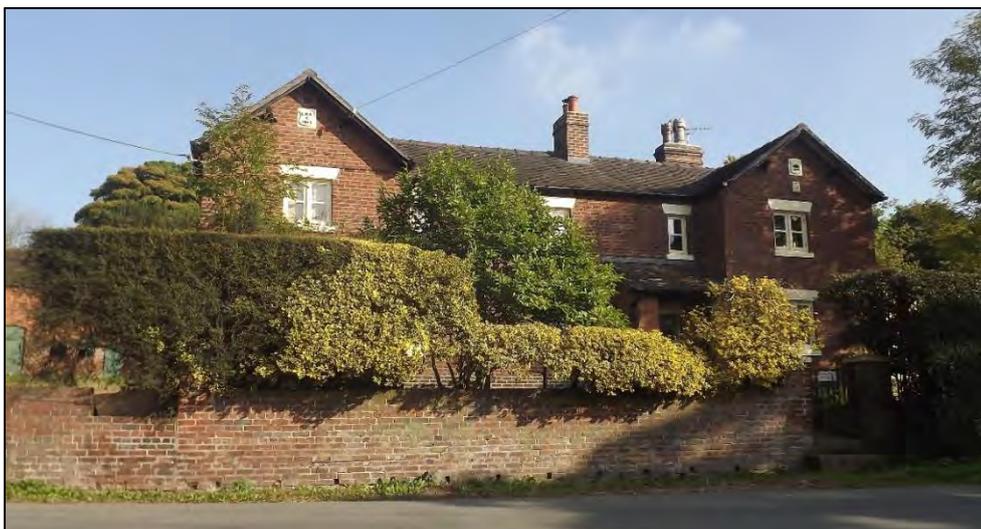
Figure 54 : Manor House Farmhouse

- 17.1 Throughout the village, the scale of the buildings is modest. Other than the 3-storey Moss Rose Farm, no building is over 2-storeys in height. Typically buildings are comprised of simple rectilinear forms with gable ended roofs of up to three bays. Changing orientations and roof levels nevertheless create interest along the street scene, and at Manor House Farmhouse, a more imposing impression is created by two end wings with projecting gables either side of a simple three bay frontage.

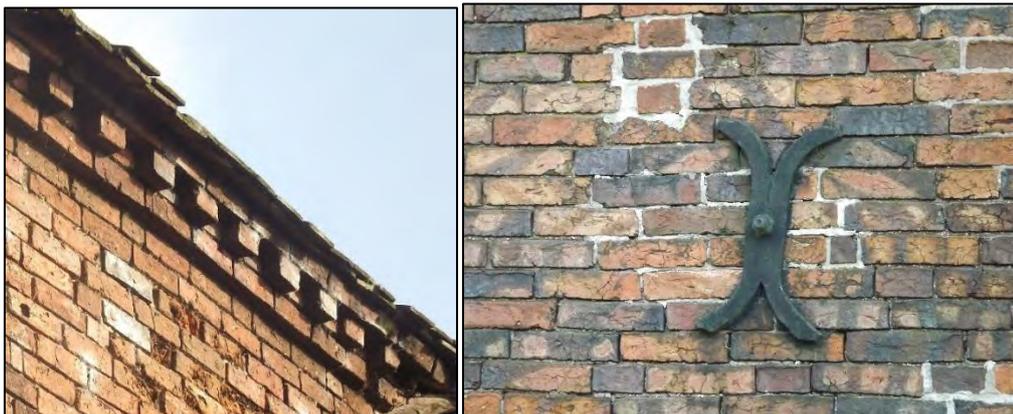
**Figure 55 & 56:** Dentilled eaves and burnt brick in Flemish bond with traditional cast iron tie bar bracket

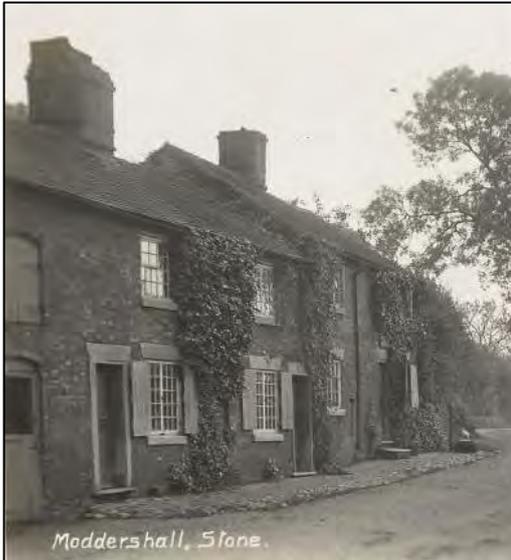
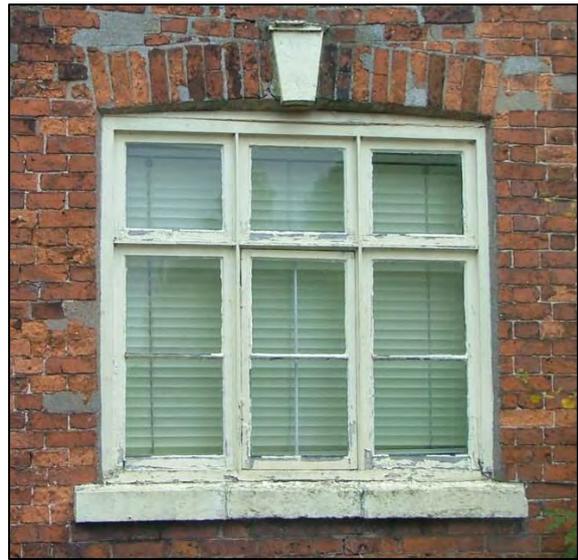
**Figure 57 & 58:** Myrtle Cottage and the Old Post Office circa 1900, with small paned casement windows in situ and historic casement window at Prospect House under simple brick header with central keyblock.

19.2 The sliding sash window is entirely absent from Moddershall village, and the side opening casement is instead found throughout. Windows to higher status farmhouses may have originally had sash windows, however, the side opening casement was a long established means of fenestration, and persisted in central Staffordshire from the 17<sup>th</sup> century on.

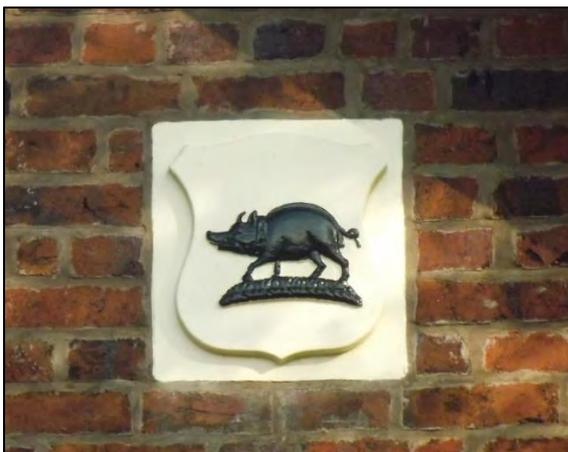
**Figure 59 & 60:** Boar plaque at Manor House Farm and 'honeycomb' brickwork to create ventilation holes in brick barn

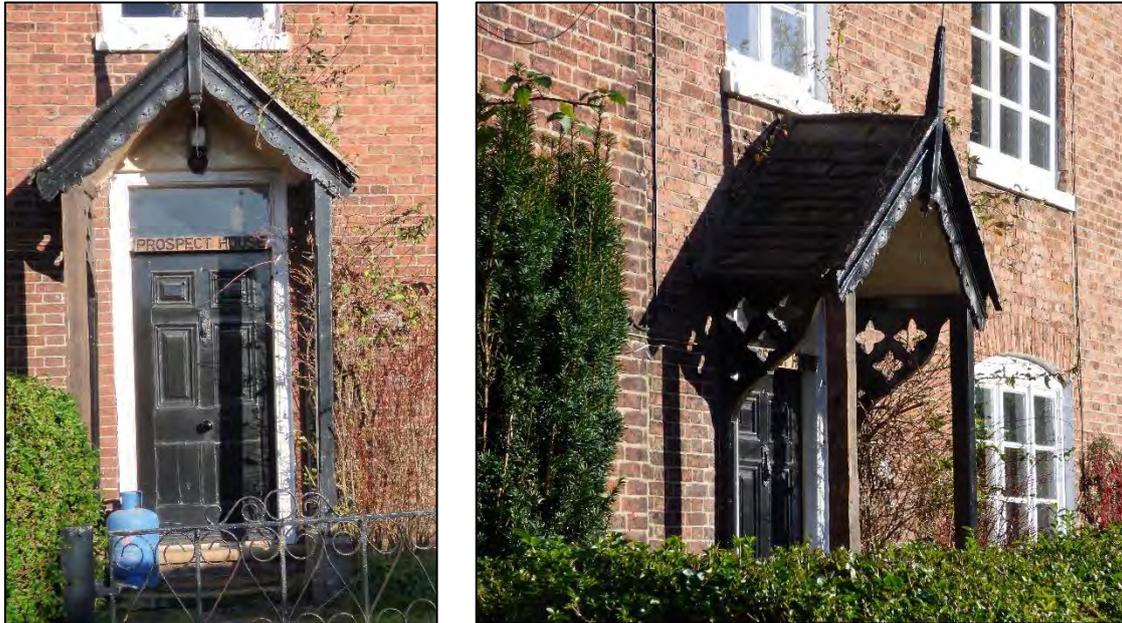
**Figure 61:** Door and porch at Prospect House

- 19.3 Few historic front doors survive, but there is a good example of a four-panel early 19<sup>th</sup> century door at Prospect House, with well-defined moulding to panels and central door knob. Often porches are later additions to houses, but some simple canopies on brackets can be found at Prospect House and Boulton's Office.
- 19.4 At Manor House Farm, the projecting gables bear moulded plaques in shields, one proclaiming the building date of 1857, the other an image of a wild boar, suggesting a connection with the Boar Inn or Board Mill further north down the road.

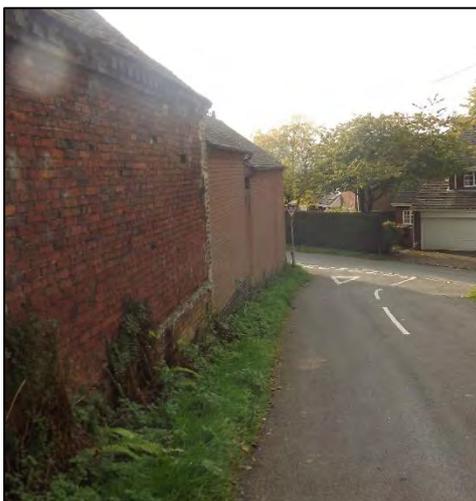
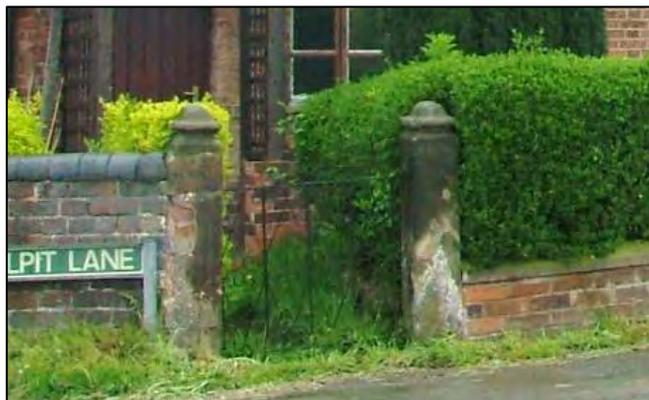
**Figures 62 & 63:** Sense of enclosure created to road side by rear wall of Manor House Farm and variety of historic walls and gate piers at the corner with Marlpit Lane

- 20.1 Historic properties tend to be bounded by brick walls with a variety of copings in brick or stone, and agricultural buildings backing onto the road create a sense of enclosure adjacent to farm yards. But the majority of the roadside boundaries are of hedging, varying from informal field boundaries, to more manicured domestic boundaries.

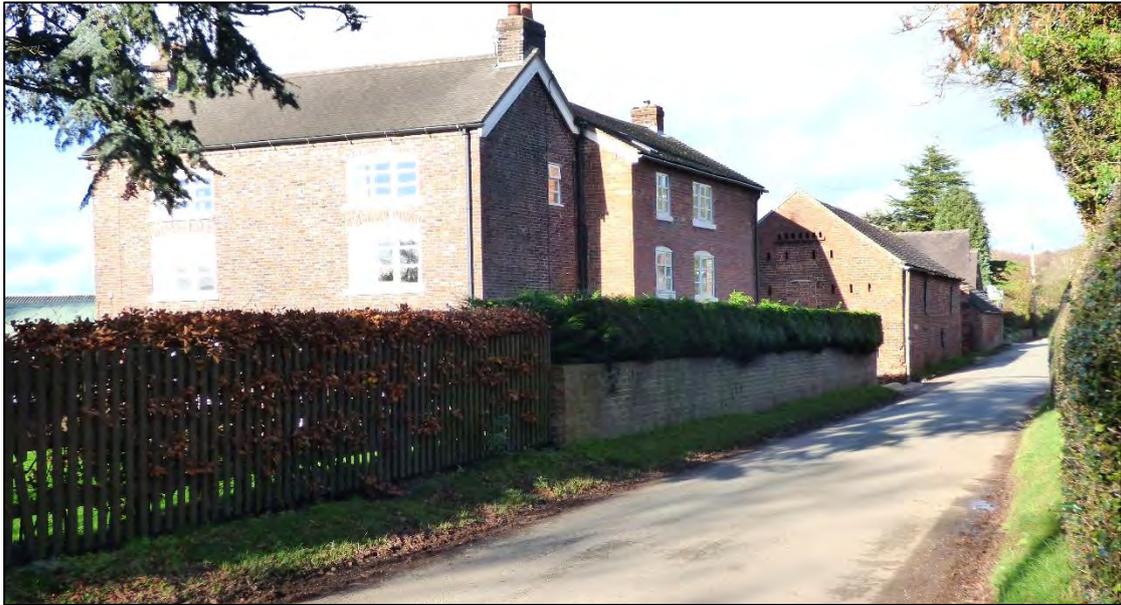
**Figure 64:** Typical mix of hedging, brick wall and roadside buildings at Moss Rose Farm

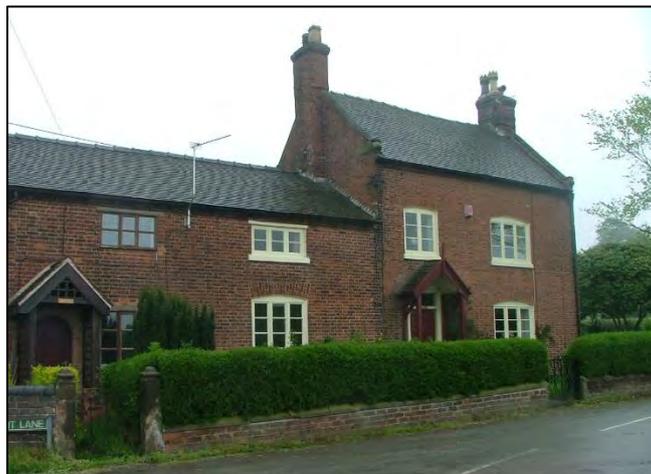
**Figure 65:** Prospect House

- 21.1 Only two buildings in Moddershall village are listed: Prospect House and the former Boulton Offices. However, many make a positive contribution to the character and appearance of the conservation area, and are identified on the plan at Figure 72.
- 21.2 **Prospect House (grade II listed)** originated as a late 18<sup>th</sup> century farmhouse of a tall but compact two-storey, two-bay front elevation with stone coped gables and simple brick details. It was extended to side and rear in the 19<sup>th</sup> century, in a linear fashion. Turning its back on the village, and wrapping around the corner of Marlpit Lane, it presents its historic elevation as an introduction to the conservation area in the approach from the south.

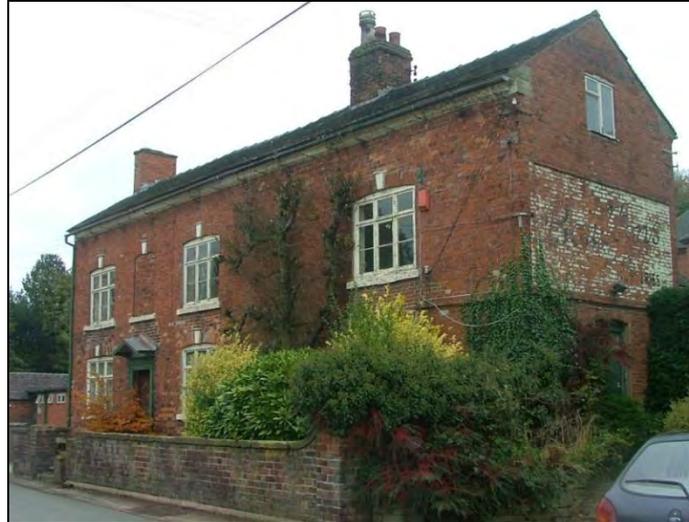
**Figure 66:** Boulton's Offices

- 21.3 **Boulton's Offices (grade II listed):** An early 19<sup>th</sup> century four-bay brick-built farmhouse of two storeys with attic. Historic casement windows feature under segmental arches with projecting keyblocks, and a moulded wood eaves cornice distinguishes the building. Set slightly back from the road behind a low brick wall it commanded views over its farmland to the west.

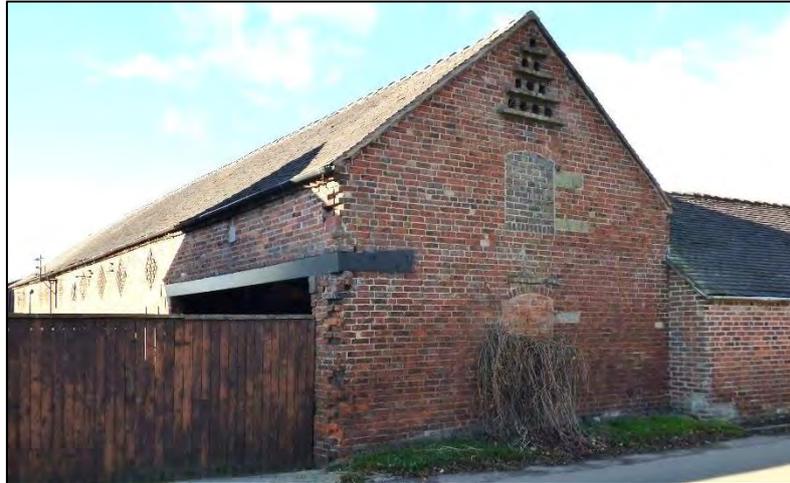
**Figure 68:** Barn at Moss Rose Farm with blocked up pitching door and openings for pigeon loft above.

21.5 **Agricultural buildings:** Detached agricultural buildings at Prospect House, Moss Rose Farm, Moddershall House and Manor House Farm are variously converted to dwellings, or remain in ancillary or agricultural use. They typically turn their backs to the roadside and retain blind elevations, without the addition of windows or rooflights, thus maintaining an anonymous character in the streetscene. Occasional shuttered openings and a variety of patterns of ventilation holes in the brickwork, however, add interest to their plain functional character, and where buildings are orientated gable onto the road this creates variety in the roof-lines.

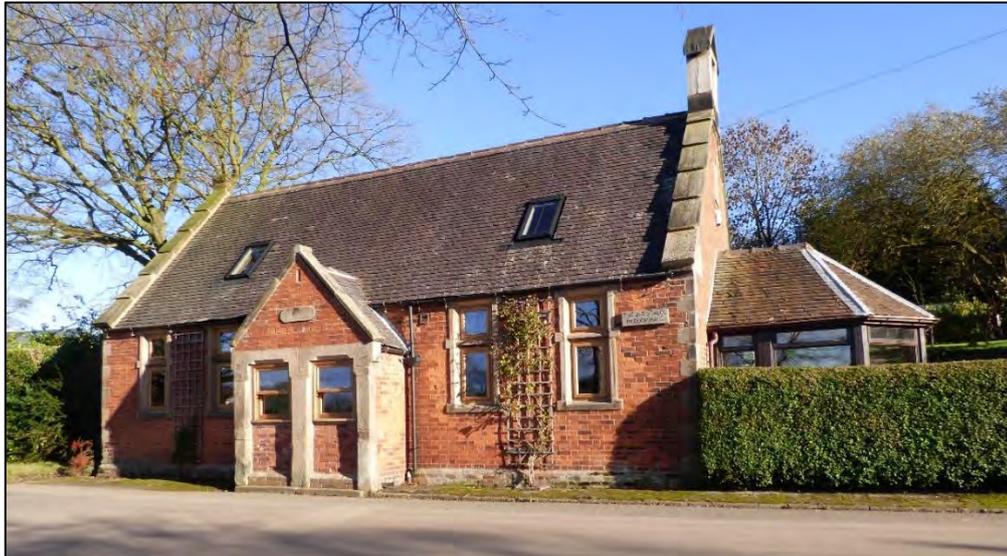
**Figure 69:** The School House

21.7 **School House (unlisted):** Now converted to domestic use, the school was built in 1844, but falling rolls caused it to close in 1966. A typical village school in miniature, it had separate boys and girls entrances under a porch (now blocked for windows), and was carried out in a 'Jacobethan' style' with heavy stone copings to the roof, stone quoins and mullioned and transomed window surrounds.

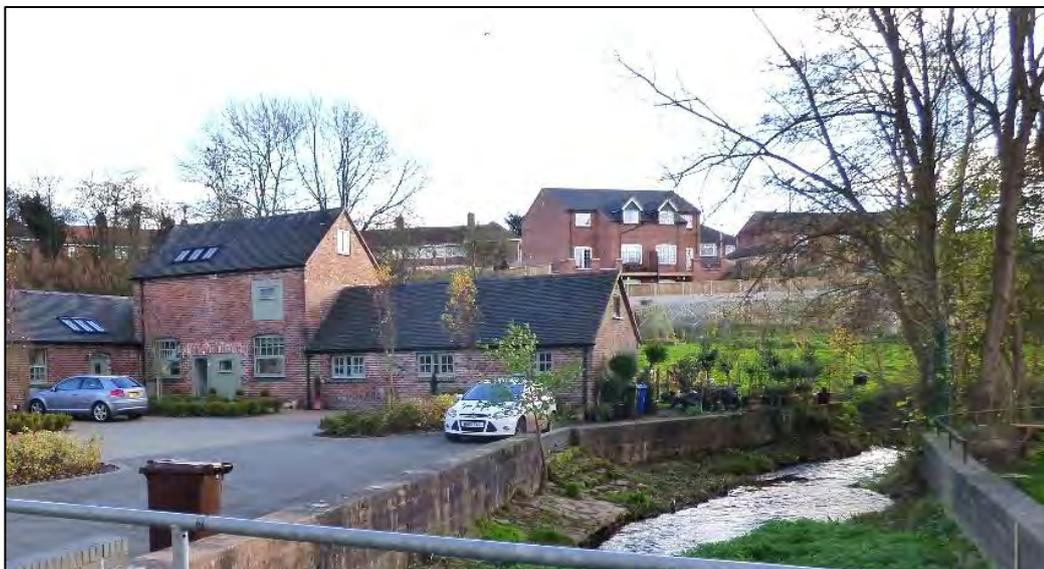
**Figure 73:** Development within the valley of prominent scale dominates the background of sensitively converted agricultural buildings at Mill Farm and harms their sense of spacious rural setting.

- 26.3 Along the ridge of the Moddershall Valley, particular care needs to be taken. Development along Airedale Road has pushed development potential to its limits adjacent to the conservation area. Here it is at a high level and screened by trees for much of the year, so any visual intrusion is negligible. But this should not be taken as creating a precedent where further along the valley where gradients, vegetation and landscape setting vary considerably.

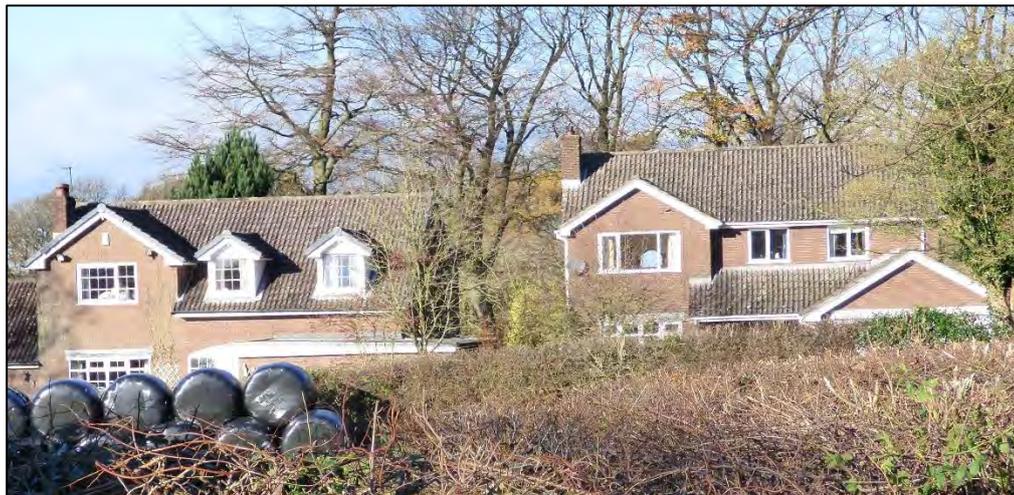
**Figure 75:** Development on the corner of Mill Lane and Moddershall Oaks with wide picture windows, concrete tiles and heavily accentuated barge boards.

- 26.6 **Form and Style of New Buildings:** Few new dwellings have been constructed in the conservation area in the last 35 years, but the failure of late-20<sup>th</sup> century development to respect the character of the area has notably diluted its built character. Particular mistakes have been in the use of inappropriately coloured or textured bricks, concrete tiled roofs, wide picture windows and the use of prominent white coloured fascia boards or bargeboards.

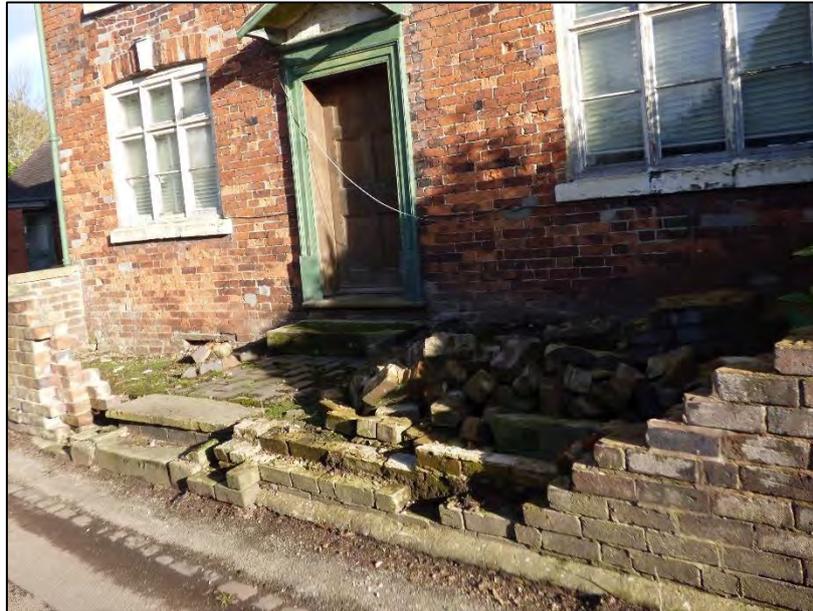
**Figure 76:** Damaged wall at Boulton's Offices, Moddershall

**26.7 Building Condition:** The majority of buildings within the conservation area are well-maintained. However, a lack of maintenance and care for heritage assets is evident in certain areas. At Boulton's Offices, the front wall of the listed house has been partially demolished by a vehicle strike, whilst 'repairs' have been carried out to the masonry in inappropriate cement based mortars, which could lead to long term erosion of the masonry.

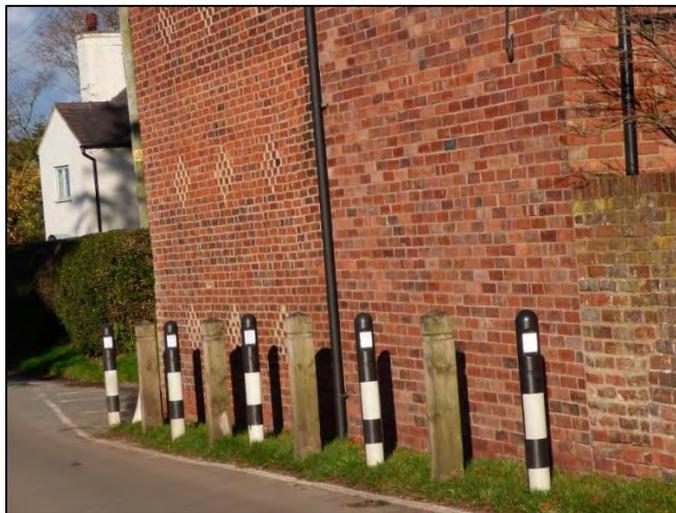
**Figure 77:** Roadside bollards at Prospect Barn create a cluttered and inconsistent appearance

- 26.14 **Highways Works:** Along the busy Longton Road highways interventions of signage, barriers and road markings are inevitable. But some works within the relatively peaceful village appear heavy handed. The double row of bollards of different styles at Prospect Barn, for example, add an unnecessary complexity within the street scene, whilst recent works on Nicholls Lane have inserted a harsh concrete kerbside in contrast to the usual soft unbound verges along the rural lanes.

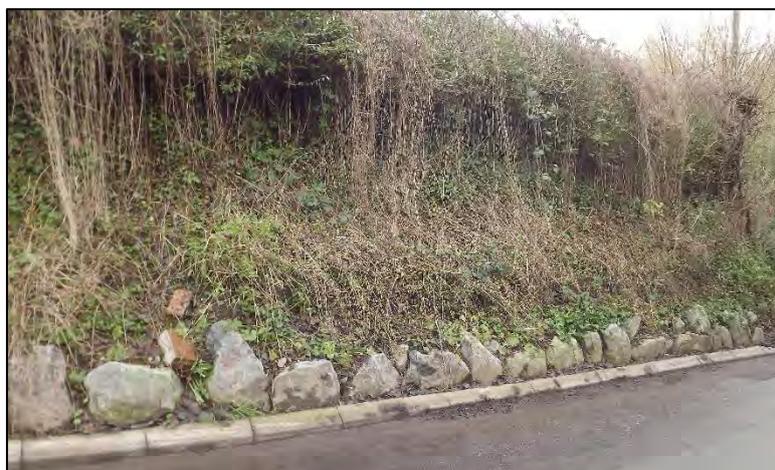
**Figure 78:** Insertion of standard concrete kerbing in place of soft verge

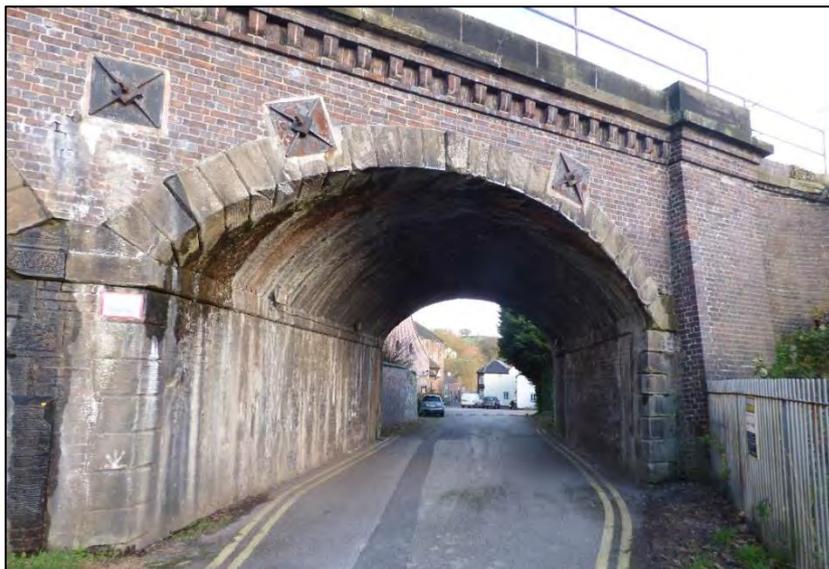
**Figure 78:** Railway Bridge on Mill Lane, Stone

- **The railway bridge west of Stone Mill:** This is a pleasant Victorian construction on the Stone to Colwich railway line, of dark red and blue bricks, dentil cornice with stone parapet above, and stone quoins and arch of a skewed elliptical form. Although it post-dates the mills it creates a clear historic boundary and gateway from the urban environment of Stone to its semi-rural industrial predecessors.
- **Land south of Nanny Goat Lane, Stone:** The previous boundary followed an indistinguishable physical route at this point. The footpath along Nanny Goat Lane follows the ridge of the gorge of the Moddershall Valley to the southeast and is an identifiable boundary for the conservation area.
