LAND NORTH OF BEACONSIDE STAFFORD STAFFORDSHIRE

ARCHAEOLOGICAL DESK-BASED ASSESSMENT

CA PROJECT: 3021 CA REPORT: 10004

JANUARY 2010

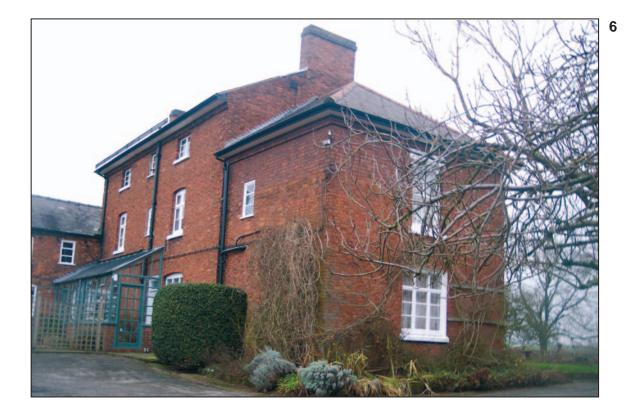
3.15 Newbuildings Farm itself is a 19th-century building, two-storeys and built in red-brick (Fig. 2, 32; Fig. 6). Additional farm buildings of similar date, including stables, lie around a stockyard to the south of the farmhouse. Two large modern Dutch barns lie to the west of the farm house. Newbuildings Cottage, a two-storey structure in a similar style, lies approximately 200m to the north of the farmhouse (Fig. 2, 31; Fig. 9). Another farm of similar date, Kent's Barn Farm, lies immediately to the north of site (Fig. 2, 36), and a number of other farms in the study area are recorded by the Staffordshire Historic Environment Record (Fig. 2, 28-30, 33-35, 37).

6 7	Newbuildings Farm House, looking north-east Former Marl Pit (E) to the south of Newbuildings Farm, looking south	PROJECT T Land Staff	North of Beac ord, Staffordsh	onside	LOGY
		DRAWN BY	SCALE	PROJECT NO.	FIGURE NO.
		LG	n/a	3021	6 & 7

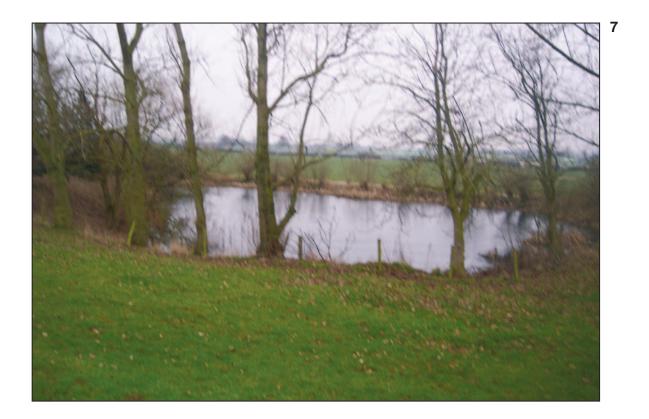
- 3.23 Newbuildings Farm is recorded in greater detail, and a large pond is recorded to the south of the building (Fig. 2, **E**). This pond is still extant (Fig. 7), and its irregular shape and location suggests it is a former marl pit. A second pit is recorded to the north of the house (Fig. 2, **F**), which is also still extant (Fig. 8). Further marl pits are recorded in the eastern and southern areas of the site, both of which were visible as large hollows during the site visit (Fig. 4, **G**, **H**). A small area of the site also extends into a brick kiln complex to the south, although no structures were depicted within the site.

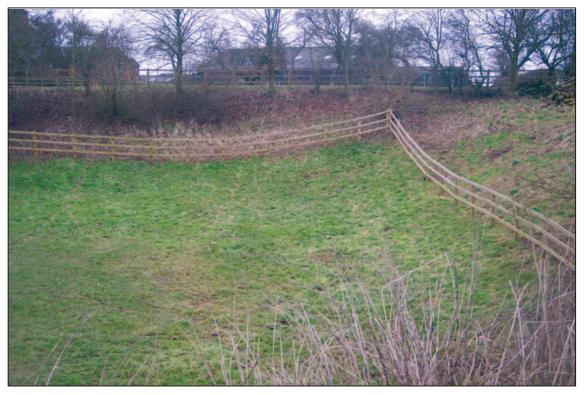
COTSWOLD A	RCHAEO	LOGY
8	Probable former Marl Pit (F) to north of Newbuilding Farm, looking west		North of Beac ord, Staffordsh		
9	Newbuilding Cottage, looking north	FIGURE TITLE Photographs			
		DRAWN BY	SCALE	PROJECT NO.	FIGURE NO.
		LG	n/a	3021	8 & 9

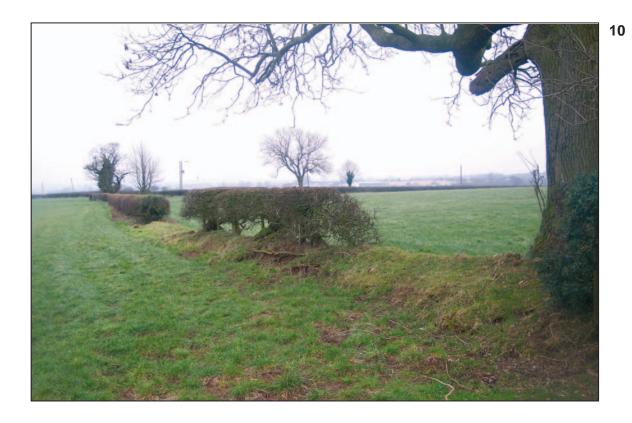
- 3.17 The site is first recorded in detail on the Tithe Map of Hopton Township, in the parish of St Mary's, Stafford. This map was produced in 1838, and is included as Fig. 3. The parish boundary as recorded on this map forms the south-western and western boundaries of the site. A low field bank, varying between 30cm and 1m high, was recorded along this boundary during the site visit (Fig. 13). A second field bank was recorded in the north-eastern area of the site, adjacent to the public bridleway running north-south through the centre of the site (Fig. 10).

- 10 Field bank in the north-eastern area of the site, looking north
- 11 Field recorded as ridge and furrow, looking east

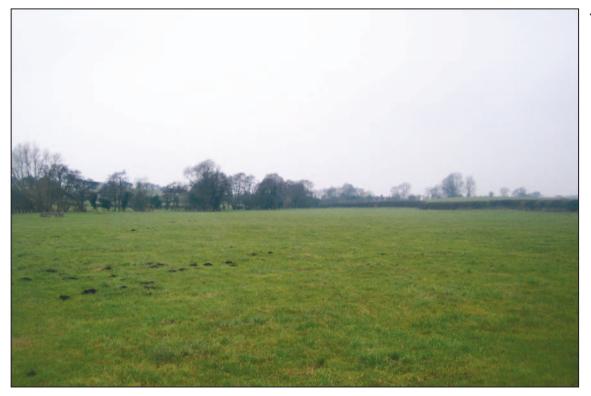
(COTSWOLD A	RCHAEO	LOGY
12 Field recorded as water meadow, looking west13 Bank along Parish boundary in south-western area		PROJECT TITLE Land North of Beaconside Stafford, Staffordshire		
of the site, looking south	FIGURE TITLE Photographs			
	DRAWN BY	SCALE	PROJECT NO.	FIGURE NO.
	LG	n/a	3021	12&13

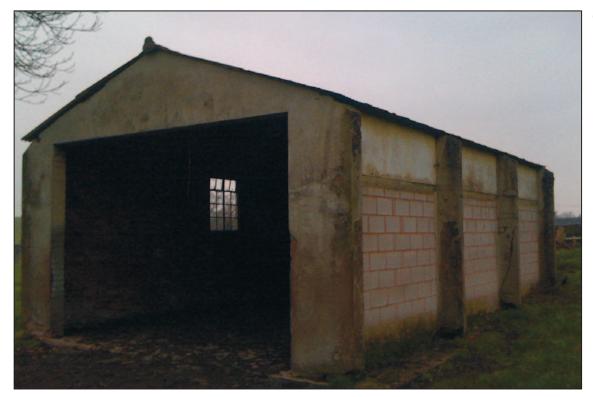
3.16 The line of the now-disused Stafford to Uttoxeter Railway runs through the southeastern area of the site (Fig. 2, **38**). The railway was opened in 1867, failed to make a profit, and was closed in 1951. The railway survives within the site as a large linear bank approximately 3m high. A break in the bank at the southern edge of the site is revetted by brick walls, and was the location of a bridge (Fig. 15). A second bridge across the Hopton Road, in the northern area of the site, is visible on aerial photographs, which extends fractionally into the site from the north. This bridge is no longer extant, and the railway bank in this area has also been removed. A small modern garage, of post-war date, lies in the eastern corner of this area (Fig. 14).

- 14 Structure in south-eastern area of the site, looking east
- 15 Former railway in south-eastern area of the site, looking south-east
